NEW MEXICO ENVIRONMENT DEPARTMENT

Re: Sierra Norte Development, Inc/Metro Verde South 3C; CGP; SIC 1521; NPDES Compliance Evaluation Inspection; NPDES #NMR10016R; May 3, 2018

NPDES Compliance Inspection Report

NPDES Construction General Permit Inspection Report – State of New Mexico

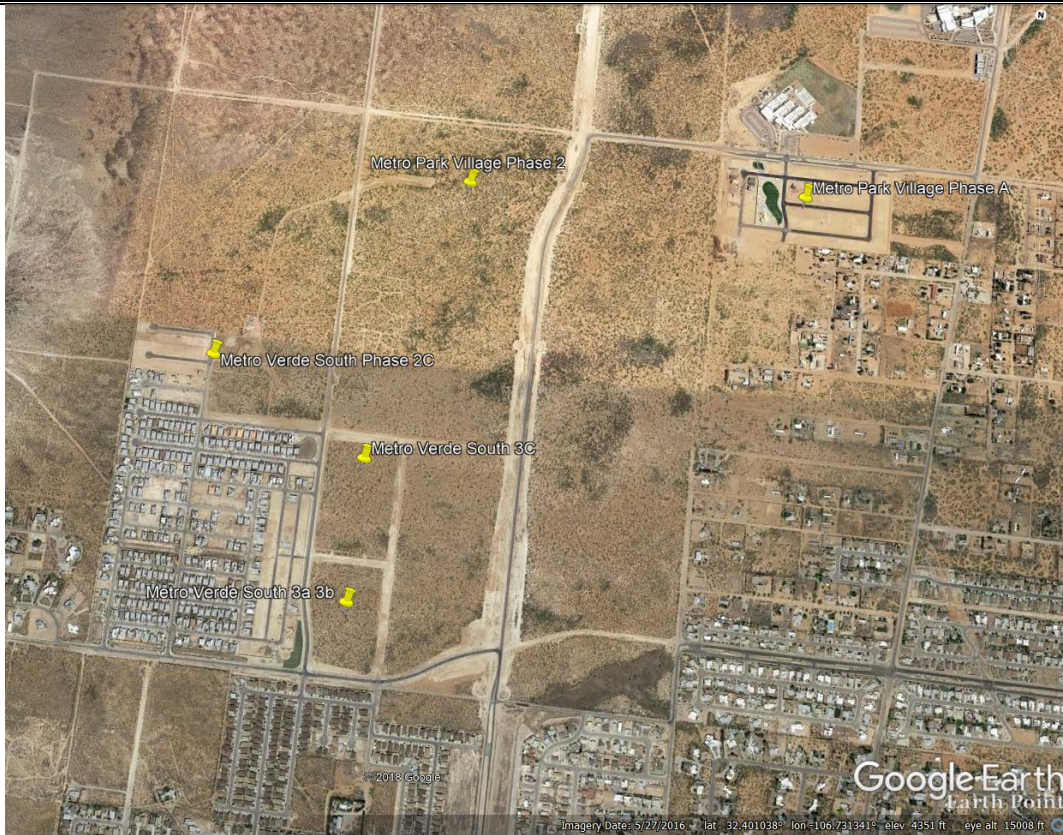
NMED/SWQB Official Photograph Log Photo # 1		
Photographer: Google Earth	Date: 4-4-17	Time: unknown
City/County: Las Cruces/ Dona Ana		State: New Mexico
Location: Metro Park Area		
Subject: Aerial image of NOI locations associated with SWPPP (taken in April 2017)

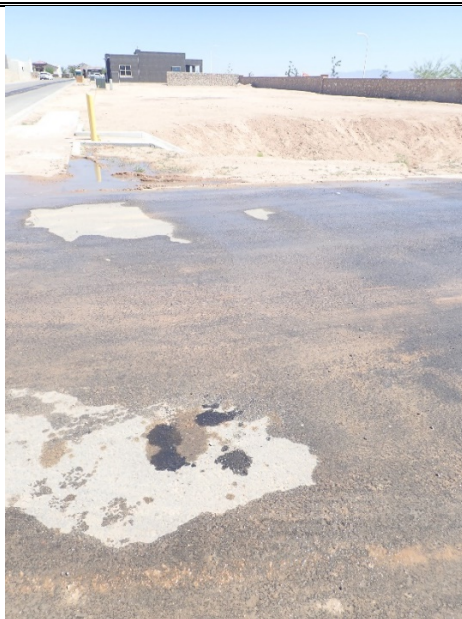
An oil leak was noted where the water truck fills up, but otherwise the site had good housekeeping. No stabilization BMPs have been designed for drainage swales and ponds. In general the housing sites will be transferred to builders, but shared areas must be stabilized. No outlet protection was installed at the ponds. Concrete washouts were utilized.

- Part 2.2.10 Storm drain outlets must be protected.
- Part 2.2.14 No documentation of method of stabilization of disturbed areas.
- Part 2.3.1.f Vehicle leaking oil (See Appendix A: cleaned up later that day)

NMED/SWQB Official Photograph Log Photo # 2		
Photographer: Jennifer Foote	Date: 5/3/18	Time: 9:54 am
City/County: Las Cruces/ Dona Ana		State: New Mexico
Location: Metro Verde		
Subject: Oil leak from water truck

As soon as you left, I notified our equipment supervisor, Chacho Gallardo, and informed him of water truck leaking fluids. Chacho immediately replaced water truck. Fluids on concrete flooring was cleaned.

- Part 2.2.14 No documentation of method of stabilization of disturbed areas. Response: Clarified in para. 10.2 of the SWPP.
- Part 2.3.1.f Vehicle leaking oil. Response: Cleaned up later that day by Gallardo Const.: See Appendix A of the NMR1000UH inspection attached.

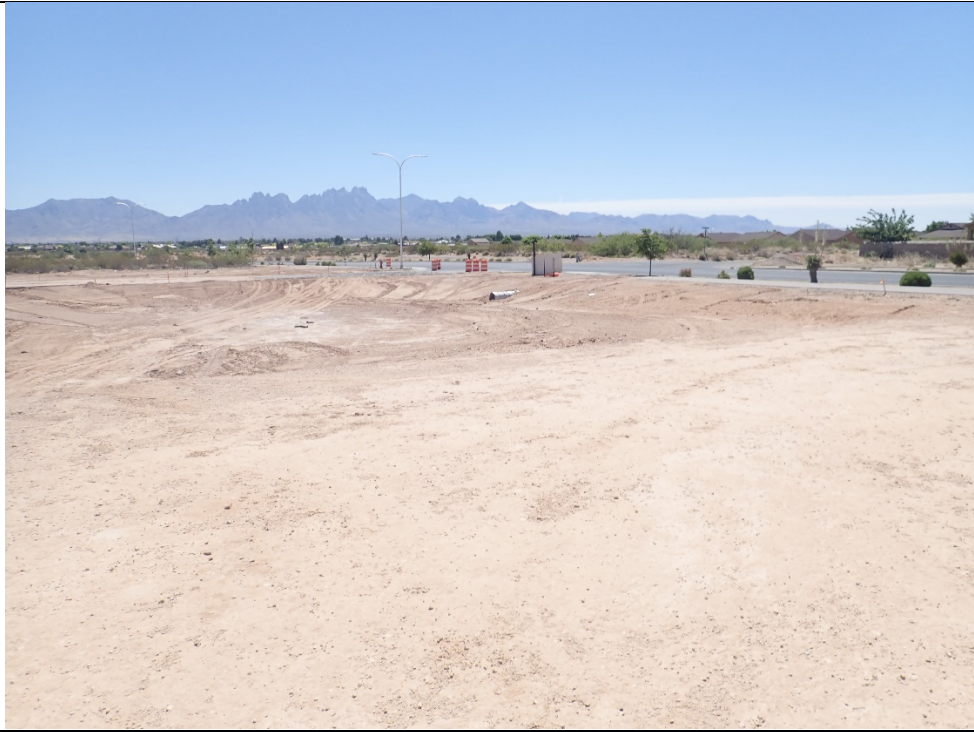
NMED/SWQB Official Photograph Log		
Photo # 4		
Photographer: Jennifer Foote	Date: 5/3/18	Time: 11:32 am
City/County: Las Cruces/ Dona Ana		State: New Mexico
Location: Metro Verde		
Subject: discharge channel no stabilization

Construction on pond commenced the following day after your visit and we corrected the problem a couple of days later since we had to expose the pipe first in order to place electrical lines. We had the pipe protected at all times to prevent any dirt being drawn into the City of Las Cruces Drainage.

- Part 2.2.10 Storm drain outlets must be protected. Response: The drain outlets were protected during electrical line placement by Gallardo Const. See Appendix A of the NMR1000UH inspection attached.
